<b>Prüfbericht - Nr.:</b> 19615510 001		<b>Seite 1 von 10</b>
<i>Test Report No.:</i>		<i>Page 1 of 10</i>
<b>Auftraggeber:</b> <i>Client:</i>	<b>M/s. ENERTECH UPS PVT. LTD.</b> S. No. 399/1-1, Plot No. 5, Bhare, P.O. Ghotawade, Near MSEB Substation, Pirangut, Tal. Mulshi, Pune- 412115, Maharashtra, INDIA	
<b>Gegenstand der Prüfung:</b> <i>Test item:</i>	SOLAR PCU (Solar Power Conditioning Unit)	
<b>Bezeichnung:</b> <i>Identification:</i>	10 KW / 10 KVA	<b>Serien-Nr.:</b> 201401296 <i>Serial-No.:</i>
<b>Wareneingangs-Nr.:</b> <i>Receipt No.:</i>	1803024992	<b>Eingangsdatum:</b> 2014.03.24 <i>Date of receipt:</i>
<b>Prüfport:</b> <i>Testing location:</i>	<b>TÜV Rheinland (India) Pvt. Ltd.</b> Plot No.17B, Electronic City Phase II Industrial Area, Hosur Road Bangalore - 560 100, Karnataka, India	
<b>Prüfgrundlage:</b> <i>Test specification:</i>	IEC 60068-2-1, IEC 60068-2-2, IEC 60068-2-14, IEC 60068-2-30 (As per MNRE / customer requirement).

<b>TEST REPORT</b>	
<b>ENVIRONMENTAL TESTING</b>	
<b>Report reference No</b> .....	: 19615510 001
Tested by (printed name and signature).....	: (see cover page) .....
Approved by (printed name and signature).....	: (see cover page) .....
Date of

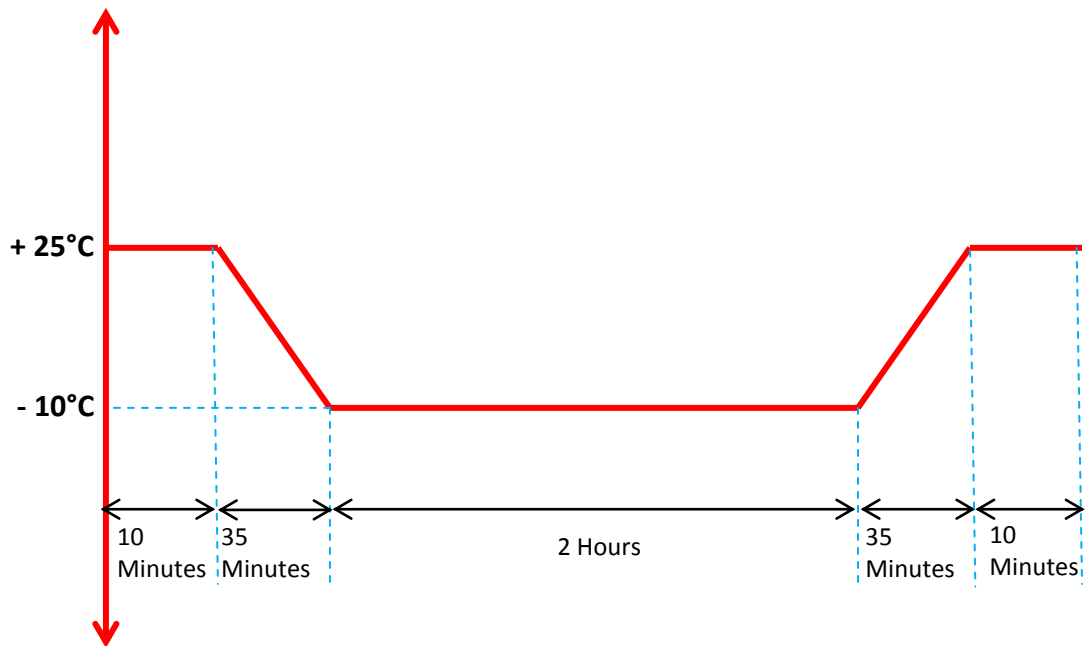
Graph:

EUT Operating Condition	Powered OFF	-
	Test Temperature	- 10°C	-
	Dwell Time	2 Hours	-
	No. of cycles	1 Cycle	-

<b>1</b>	<b>Cold Test</b>		<b>P</b>
1.1	Pre-checks		P
1.1.1	Examination before environmental conditioning.		P
1.1.1.1	Physical damages	EUT in good condition at the beginning of the test	P
1.1.1.2	EUT working condition	EUT was working fine before the cold test.	P
1.2	Cold Test specification

1.3	Post check: Examination after environmental conditioning		P
1.3.1	Physical damages	No physical damages were observed	P
1.3.2	EUT working condition	EUT was working fine after the cold test	P

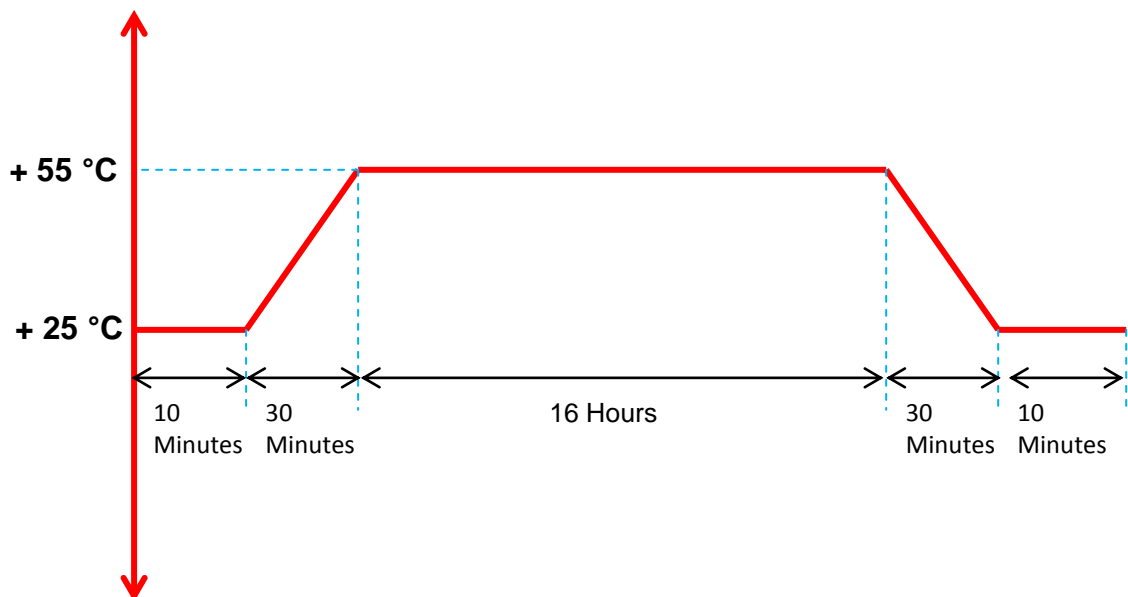
Graph:

EUT Operating Condition	Powered OFF	-
	Test Temperature	+55°C	-
	Dwell Time	16 Hours	-
	No. Of cycles	1 Cycle	-

<b>2</b>	<b>Dry Heat Test</b>		<b>P</b>
2.1	Pre-checks		P
2.1.1	Examination before environmental conditioning.		P
2.1.1.1	Physical damages	EUT in good condition at the beginning of the test	P
2.1.1.2	EUT working condition	EUT was working fine before the dry heat test.	P
2.2	Dry Heat Test Specification

2.3	Post check: Examination after environmental conditioning		P
2.3.1	Physical damages	No physical damages were observed.	P
2.3.2	EUT working condition	EUT was working fine after the dry heat test	P

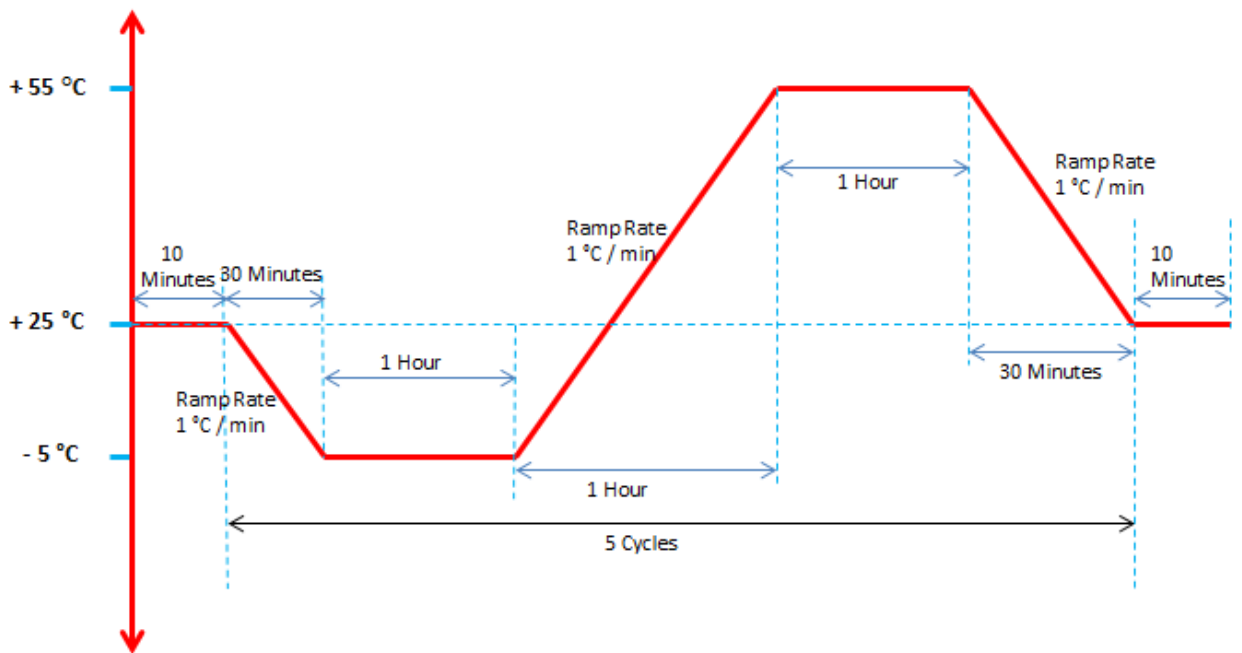
Graph:

EUT Operating Condition	Powered OFF	-
	Test Temperature	Upper: +55° C Lower: -5°C	-
	Rate of change of temperature	1°C/min	-
	Dwell Time	1 Hour at each temperature	-
	No. of cycles	5 Cycle's	-

<b>3</b>	<b>Change of Temperature</b>		<b>P</b>
3.1	Pre-checks		P
3.1.1	Examination before environmental conditioning.		P
3.1.1.1	Physical damages	EUT in good condition at the beginning of the test	P
3.1.1.2	EUT working condition	EUT was working fine before the change of temperature test.	P
3.2	Change Of Temperature Test Specification

3.3	Post check: Examination after environmental conditioning		P
3.3.1	Physical damages	No physical damages were observed	P
3.3.2	EUT working condition	EUT was working fine after the change of temperature test.	P

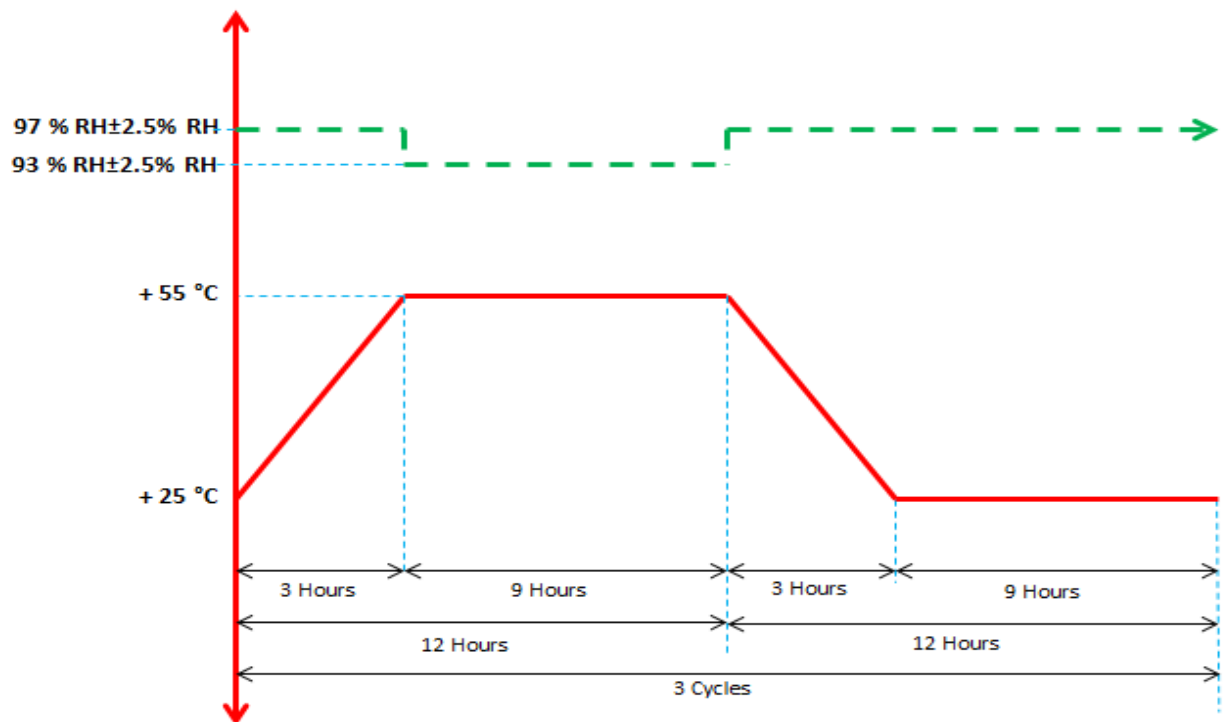
Graph:

EUT Operating Condition	Powered OFF	-
	Ramp –up / -down time	3 Hours	-
	One Cycle duration	12 Hours +12 Hours	-
	No. of cycles	3 Cycle's	-
	Total Test Duration	72 Hours	-

<b>4</b>	<b>Damp Heat cyclic</b>		<b>P</b>
4.1	Pre-checks		P
4.1.1	Examination before environmental conditioning.		P
4.1.1.1	Physical damages	EUT in good condition at the beginning of the test	P
4.1.1.2	EUT working condition	EUT was working fine before the damp heat cyclic test	P
4.2	Damp Heat Cyclic Test Specification

4.3	Post check: Examination after environmental conditioning		P
4.3.1	Physical damages	No physical damages were observed.	P
4.3.2	EUT working condition	EUT was working fine after the damp heat cyclic test.	P
