Prüfbericht - Nr.: 19615519 001		Seite 1 von 13	
<i>Test Report No.:</i>		<i>Page 1 of 13</i>	
Auftraggeber: <i>Client:</i>	ENERTECH UPS PVT. LTD. S. No. 399/1-1, Plot No. 5, Bhare, P.O. Ghotawade, Near MSEB Substation, Pirangut, Tal. Mulshi, Pune- 412115, Maharashtra, INDIA		
Gegenstand der Prüfung: <i>Test item:</i>	SOLAR PCU		
Bezeichnung: <i>Identification:</i>	6 KW / 6 KVA	Serien-Nr.: <i>Serial No.:</i>	201401292
Wareneingangs-Nr.: <i>Receipt No.:</i>	1803024992	Eingangsdatum: <i>Date of receipt:</i>	2014.05.07
Prüfört: <i>Testing location:</i>	TÜV Rheinland (India) Pvt. Ltd. 82/A, West Wing, 3rd Main Road, Electronics City Phase 1 Bangalore – 560 100		
Prüfgrundlage: <i>Test specification:</i>	As per IEC 60529: 2001-02 Edition 2.1, (IP21)		
Prüfergebnis: <i>Test Result:</i>	See "Section 2" & "Section 3"		
Prüflaboratorium: <i>Testing Laboratory:</i>	TÜV Rheinland (India) Pvt. Ltd. 82/A, West Wing, 3rd Main Road, Electronics City, Phase 1 Bangalore – 560 100

Test item description	Solar PCU
Manufacturer	M/s. ENERTECH UPS PVT. LTD.
Model and/or Type reference	6 KW / 6 KVA
Serial no.	201401292
EUT Rating	CAPACITY: 6 KW / 6 KVA MAINS INPUT: 180-260 VAC, 50Hz INV. OUTPUT : 230 VAC

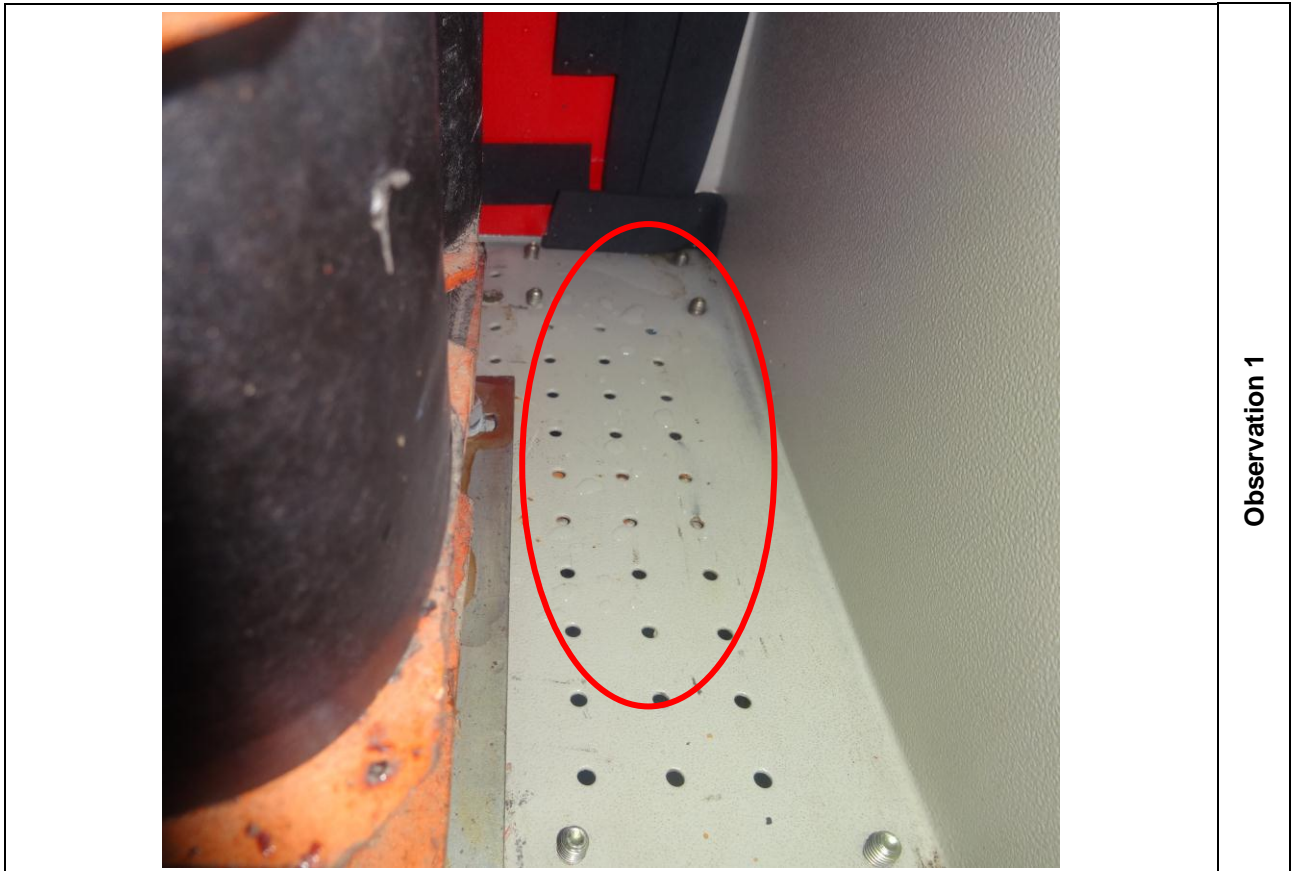
Observation 1

IP x1: There was a water deposition on the bottom cover of the PCU.
(Refer observation1 and Observation 2 photos on page no.13.)

IPX1 Test		
Test for second characteristic numeral x1		
Test condition	Description	Remark
Test Lab ambient conditions		-
Temperature.....:	25.2°C	-
Humidity.....:	59%rh	-
Delivery rate	1mm/min ±5%	-
Distance from nozzle to enclosure surface	200mm	-
Test duration	10 min.	-
Visual check for water ingress	After exposure, EUT was gently cleaned before opening for the deposited water on the enclosure. On opening of enclosure there was water deposition on the bottom cover of the enclosure. Refer photos on page no. 13	-
