# Enertech UPS Pvt. Ltd.

PROJECT NUMBER: 4787286290

Models	Nominal AC output Power (KVA)	Operational Voltage (V)	Operational Frequency (Hz)	Battery Voltage (V)	Ingress Protection	Dimension W x D x H (mm)	Weight (Kg)
Sun Magic 5KVA	5	230±2%	50±5%	120	-	NA	110

ENVIRONMENTAL TEST FOR 5 KVA/120V PCU		
<p>a.</p>	<p><u>Environmental Testing on Sample No:</u> <u>144188.1</u></p> <p>Dry Heat Test: 50°C±2°C for 16 hours</p>	<p><u>Observation</u></p> <p>Equipment functioning            Pass <input checked="" type="checkbox"/>    Fail <input type="checkbox"/></p> <p>Initial Insulation Resistance:    Pass <input checked="" type="checkbox"/>    Fail <input type="checkbox"/> _550_ Mohm</p> <p>Insulation Resistance Post</p> <p>Dry Heat: _550_ Mohm            Pass <input checked="" type="checkbox"/>    Fail <input type="checkbox"/></p>
<p>b.</p>	<p>Damp Heat Test (Steady state): 40°C, 95% RH for 4 days</p>	<p>Equipment functioning            Pass <input checked="" type="checkbox"/>    Fail <input type="checkbox"/></p> <p>Initial Insulation Resistance:    Pass <input checked="" type="checkbox"/>    Fail <input type="checkbox"/> _550_ Mohm</p> <p>Insulation Resistance Post</p> <p>Damp Heat Test:

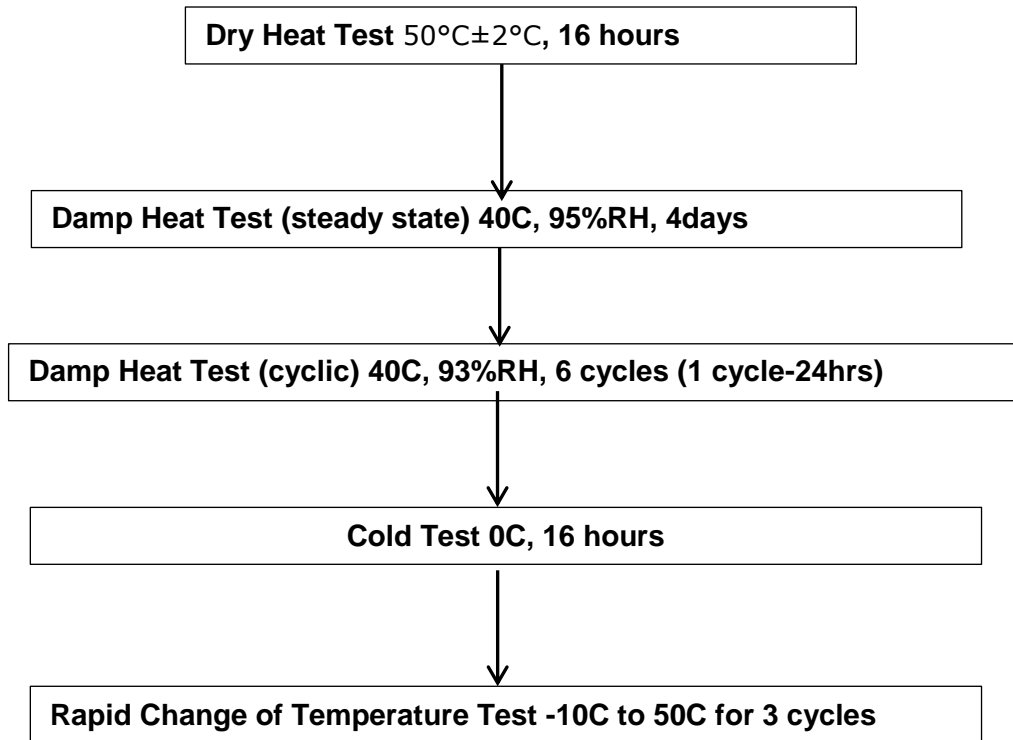
Test Plan:

- a) Dry Heat Test: 50°C±2°C for 16 hours
- b) Damp Heat Test (Steady state): 40°C, 95% RH for 4 days
- c) Damp Heat Test (Cyclic): 40°C, 93% RH for 6 cycles (duration of one cycle shall be 24hrs)
- d) Cold Test: 0°C for 16 hours
- e) Change of temperature Test: -10°C to 50°C for 3 cycles (rate of change in temperature shall be 3°C per minute)
